# Prevention of medical adhesive-related skin injury (MARSI) during vascular access

**Andrew Barton,**  
Nurse Consultant, Intravenous Therapy  
and Vascular Access, Frimley Health  
NHS Foundation Trust

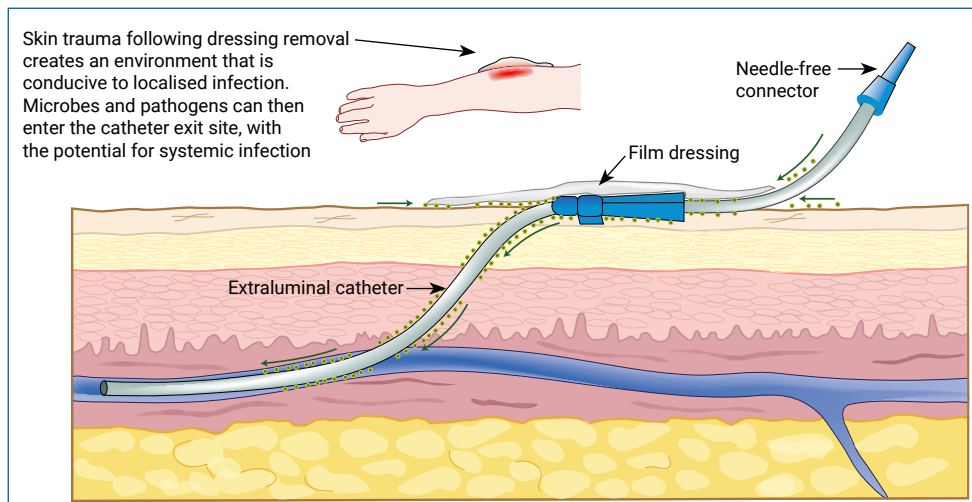
Figure 1. Catheter exit-site infection

contamination that causes CRBSI can occur in the internal lumen of the catheter (intraluminal infection), which provides a direct pathway into the bloodstream, and/or on its external surface (extraluminal infection) (Figure 1). The contamination is usually due to:

- Poor practice during manipulation of the needle-free connector or
- Migration of pathogens from the catheter exit site along the outside surface of the catheter (Inagaki and El-Feghaly, 2019).

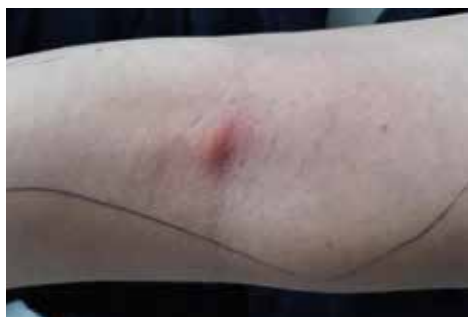
**Figure 2.** Vascular access device exit-site infection: phlebitis (inflammation of the vein) can be seen at the exit site, with erythema on the surrounding area

followed by pain and localised swelling (oedema) around the catheter exit site (Brooks, 2016). These signs are usually indicative of phlebitis (Figure 2). Three types of phlebitis are associated with VAD: mechanical, chemical and bacterial. The latter occurs when pathogens enter the bloodstream or lumen via the broken skin under the dressing and/or at the catheter exit site. All three types can be avoided with good VAD insertion technique, adherence to care bundles and provision of robust care (Mihala et al, 2018).

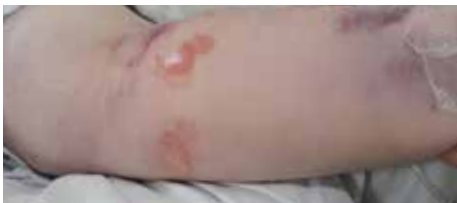
*Tension injury/blistering: distension of skin under the adhesive dressing creates shear forces that lead to the separation of the epidermis from the dermis*

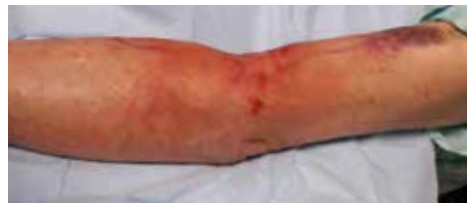
*Irritant contact dermatitis: occurs following contact with a chemical irritant. The area of irritation often correlates to the area of skin covered with a dressing*

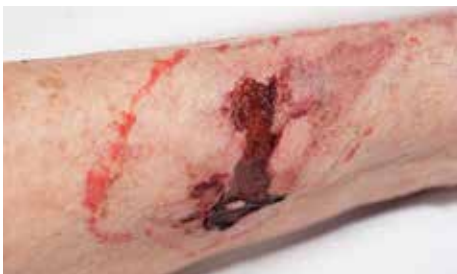
*Skin tear: removal of an adhesive medical device has created shearing, friction and/or blunt forces, resulting in the skin layers being torn; skin tears can be partial or full thickness*

Skin tear	Skin cuts or scrapes (shearing)  Rubbing (friction)	Skin is pulled away and the layers of the skin separate. This can cause either a partial-thickness wound (one that extends into the epidermis and dermis) or a full-thickness wound (one that extends into fat and muscle layers)		Use of a sterile silicone medical adhesive remover
Dermatitis	Irritant contact dermatitis	Response to contact with a chemical irritant in the adhesive	The skin is inflamed (red) and can become blistered, dry, thickened and cracked  Injury caused by shear force	It is recommended that, at dressing changes, the area around the VAD exit site should be cleansed with chlorhexidine. However, this can contribute to skin injuries, especially if the area is not allowed to dry before a new film dressing is placed over the device	Use of a sterile silicone barrier film before application of adhesive products
