# Novel stoma appliances to minimise complications and improve patient outcomes

Fiona Le Ber

### Aura Plus

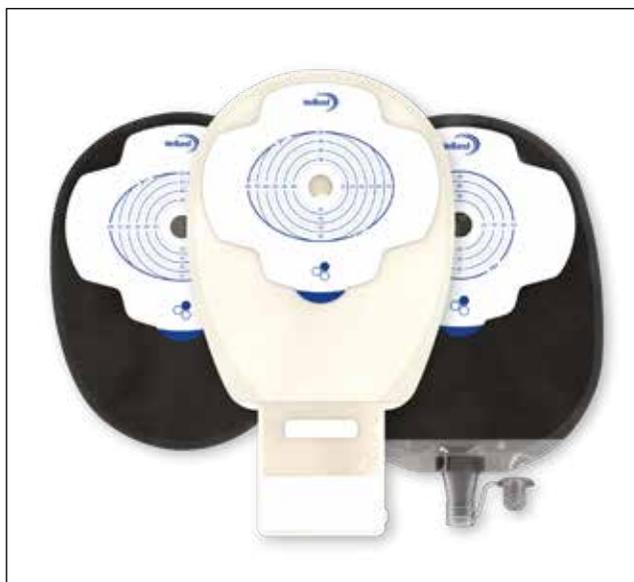
Figure 1. CliniMed Aura Plus range

The Aura Plus range has been designed with a unique plus shaped flange for even greater security, with the flange designed to conform around any body shapes which surround the stoma. Aura Plus is available in a choice of pouch colour, sand and black, with a clear pouch also available (Figure 1). The adhesive flange is the Hyperflex<sup>®</sup> hydrocolloid formulation which

contains medical grade Manuka honey. Aura Plus is available in a range of pouch and flange sizes, so there are options to suit the individual needs of different stoma patients.

The unique plus shaped flange is specifically designed to reduce the risk of leaks. The cutaway areas which form the plus shape help the flange conform around the body, which increases security for the patient, especially when the patient is moving. The flange also reduces the risk of creases forming when the pouch is applied, which reduces the risk of leaks due to the decrease in potential leakage channels.
